FIELD INSPECTION REPORT

Project Name:	Mountain Valley Pipeline	Inspector:	Matthew Grant
Inspection Date:	Tuesday, September 29, 2020	Project Contact:	Brian Clauto
Spread H: Montgomery	MP 227.5-227.3 AR-MN 268 ATWS 474, 473, 473A	Weather:	Dry

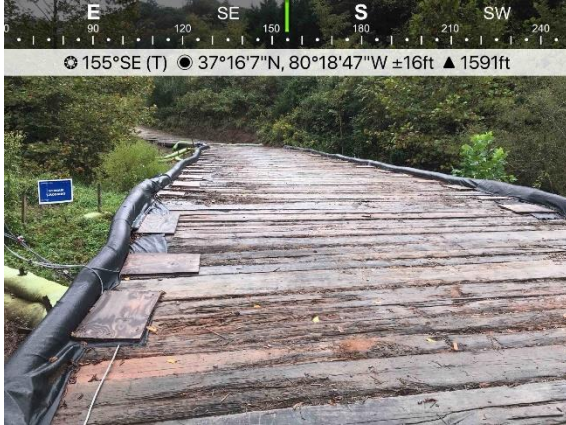
- Figure 1: Designated crossing S-G36 on AR MN 268, ECD's are in place.

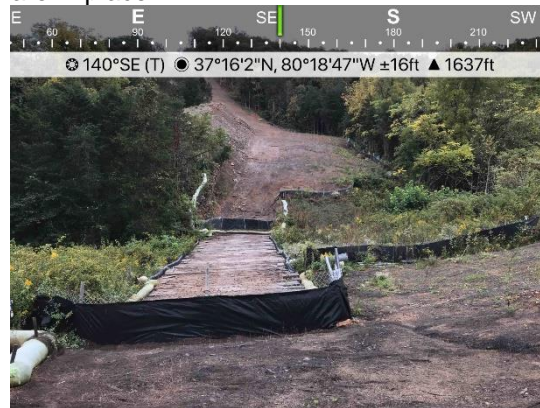
- Figure 2: Designated stream crossing S-G38, ECD's are in place.

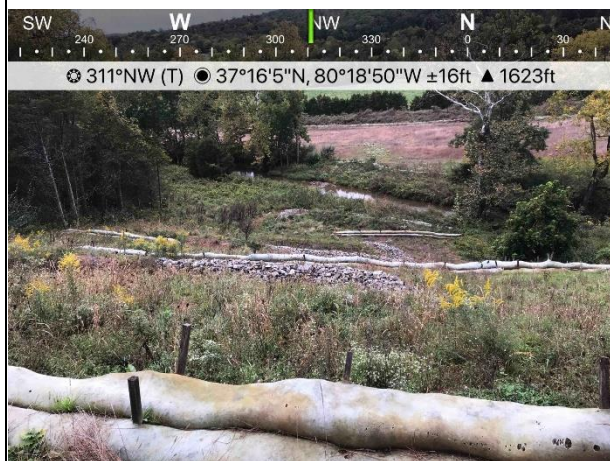
- Figure 3: Permanent & temporary waterbars are in place and functioning above crossing S-G36

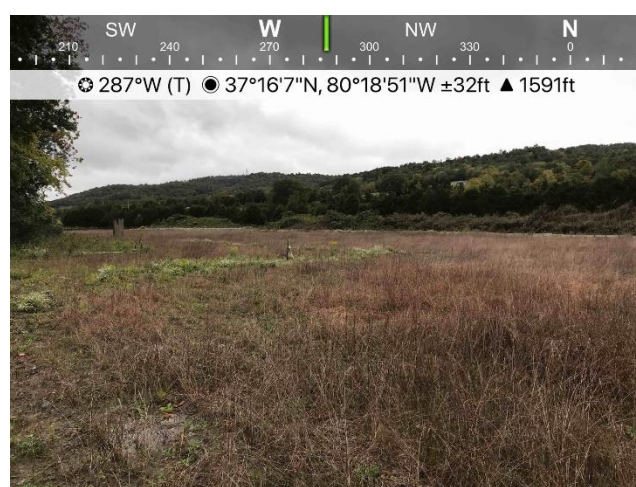
- Figure 4: ATWS 474, 473 are currently dormant, ECD's are in place.
